Sanitary Main Inspection - Service Report

Property: Green Dolphin Commons

Address: 3205 Green Dolphin St, Tarpon Springs, FL 34689

Date of Work: 06/02/2026

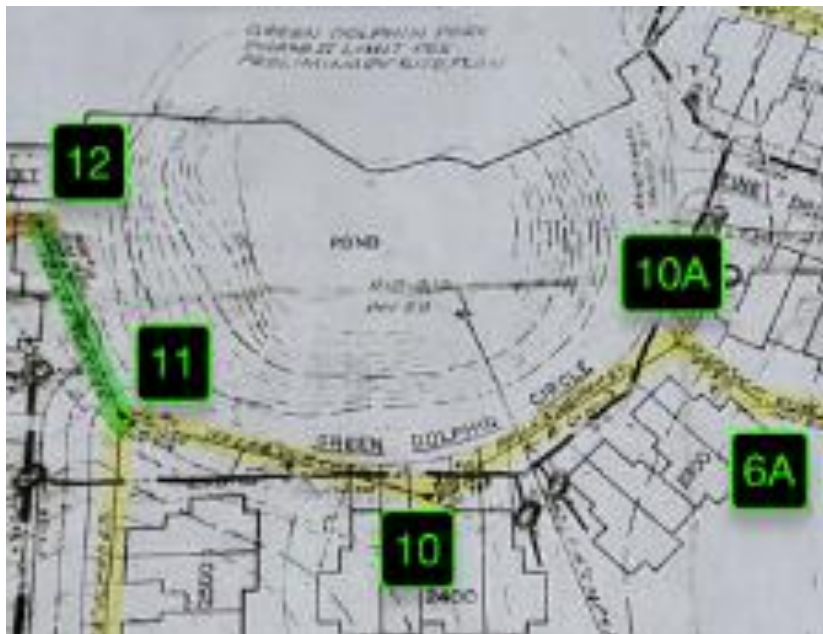
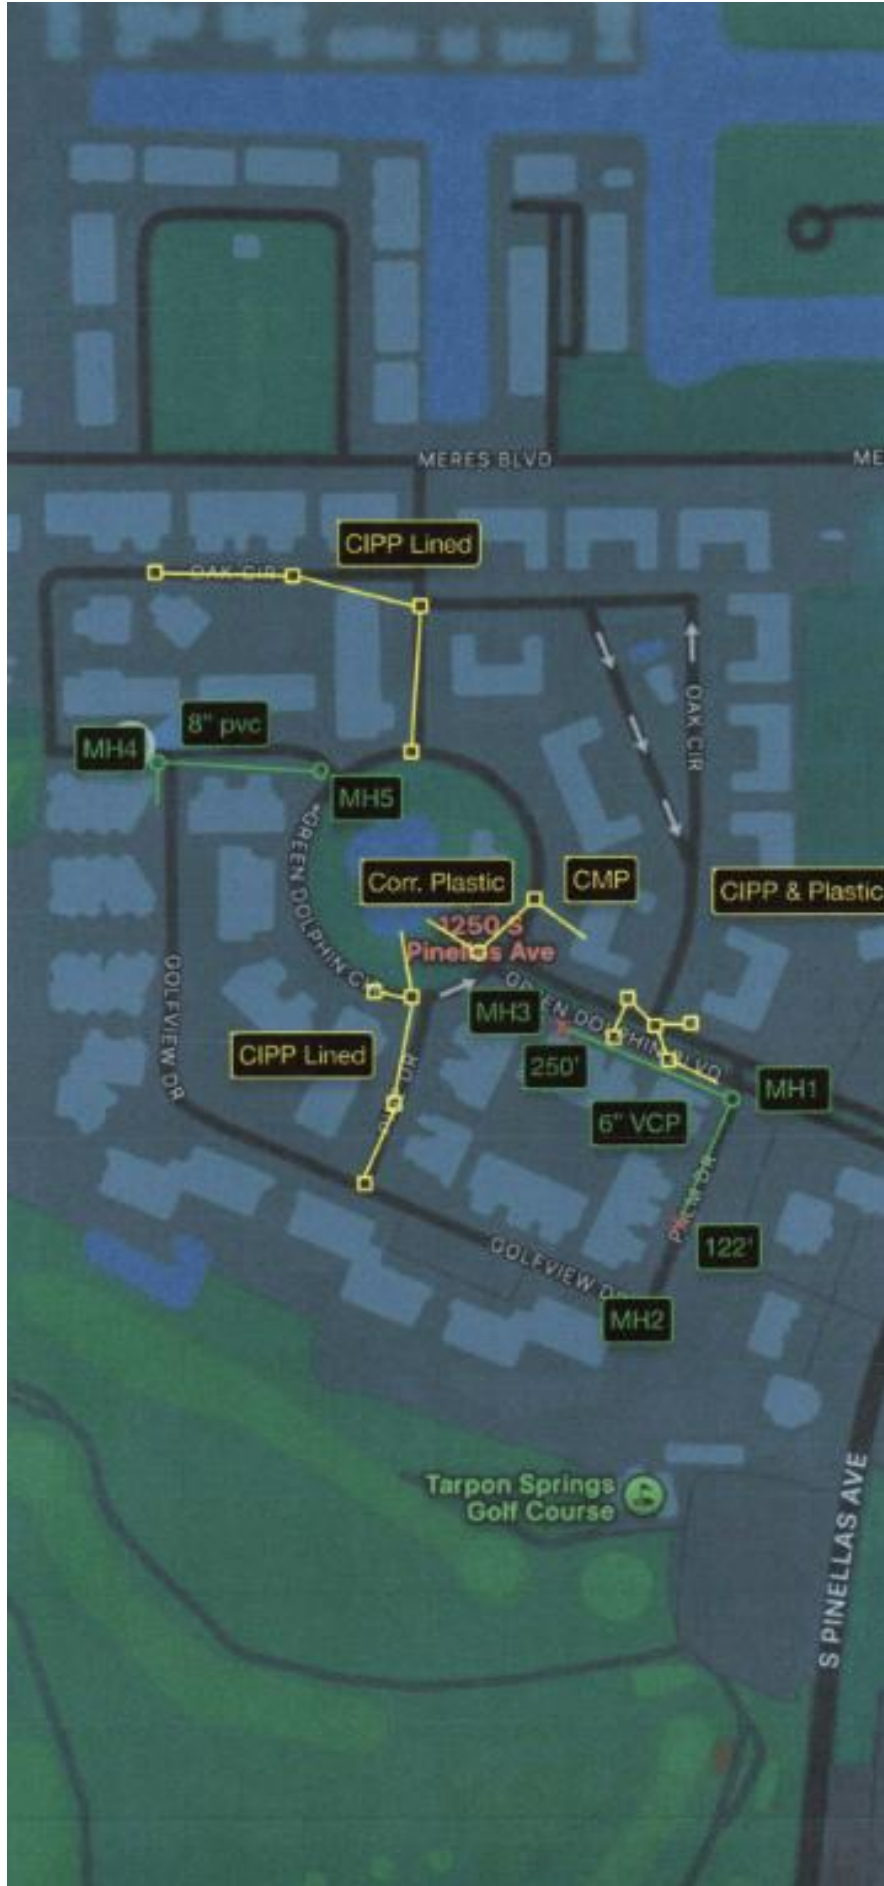
Of the pipes inspected, PRR did not identify any defects in the pipe sections beneath the above-mentioned roadways in either storm or sanitary drain lines. Most lines run parallel to the roads, in the lawn areas of the buildings. See diagrams below.
