Windstorm Mitigation Report

9th Fairway Condominium at Green Dolphin Park

Tarpon Springs, FL

As of 01-30-2025 | FPAT File# MUD2524210

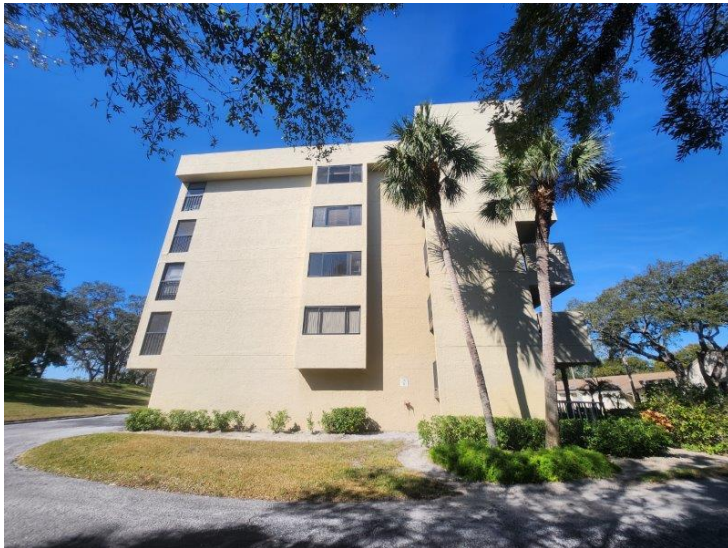
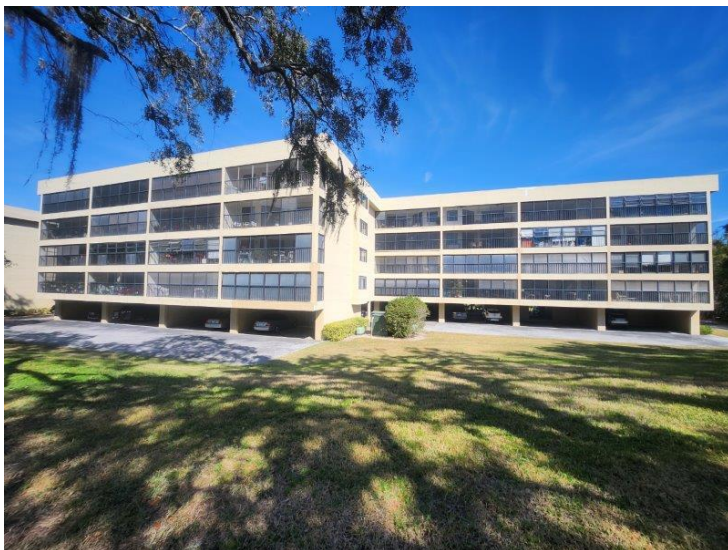
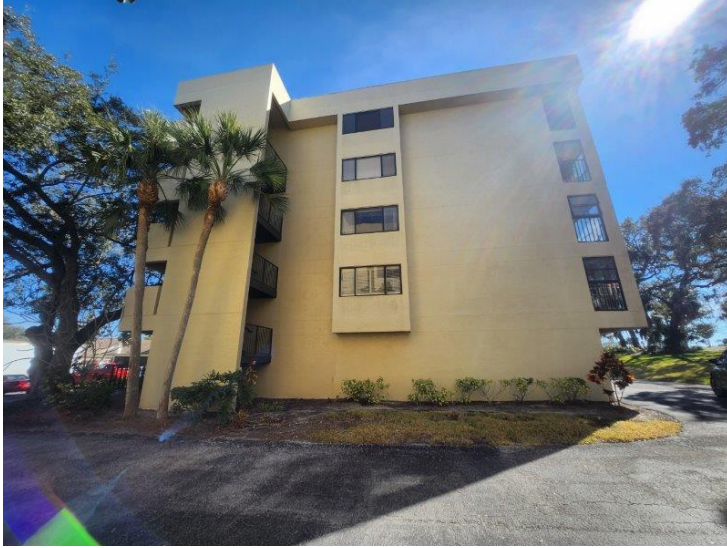
Exterior Elevation

- 5. Roof Geometry:** **Flat Roof**
Comments: Inspection verified a flat roof shape.
- 6. SWR:** **No**
Comments: SWR does not apply to reinforced concrete roof decks.

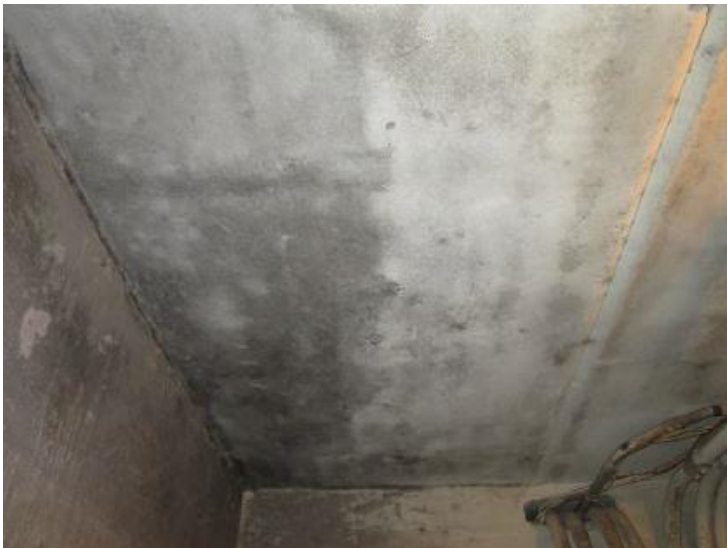
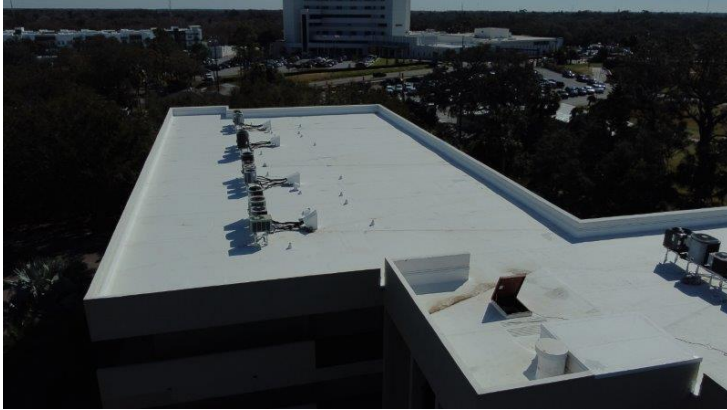
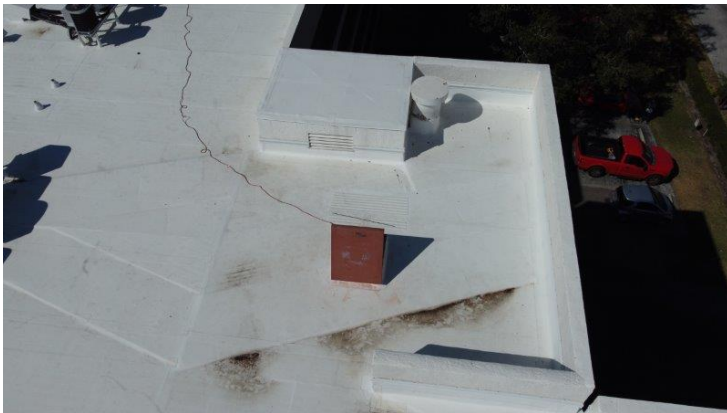
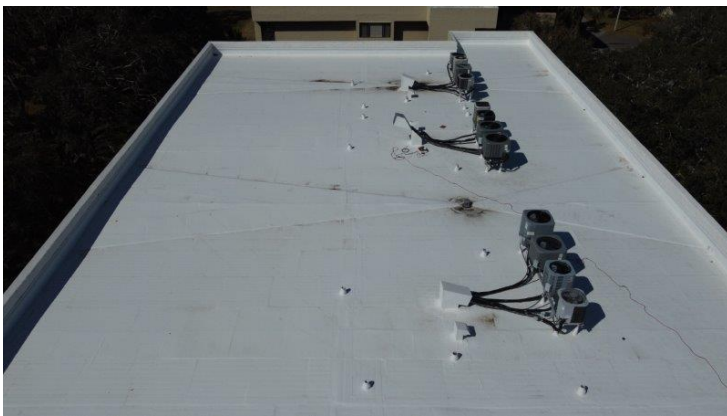
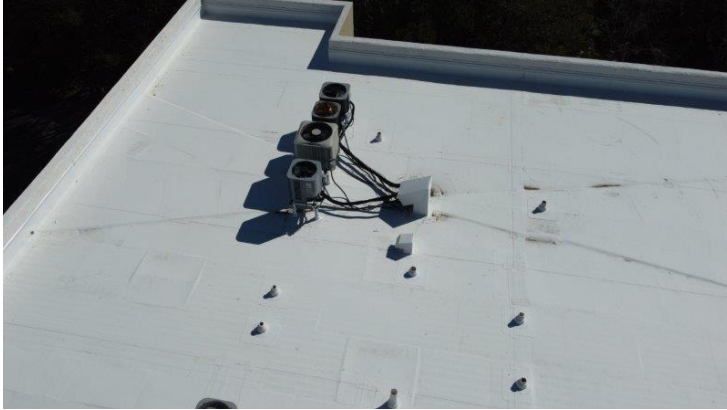
Roof Construction

- 3. Roof Deck Attachment:** **Reinforced Concrete Roof Deck**
Comments: Inspection verified a roof structure composed of pre-cast structural concrete designed to be self supporting and integrally attached to the wall / support system.

- 4. Roof to Wall Attachment:** **Structural**
Comments: Inspection verified a roof structure composed of pre-cast structural concrete designed to be self supporting and integrally attached to the wall / support system.

- 2. Roof Covering:** **FBC Equivalent**
Comments: The roof covering was replaced in 2024. The roof permit was confirmed and the permit number is 24-572. This roof was verified as meeting the building code requirements outlined on the mitigation affidavit.

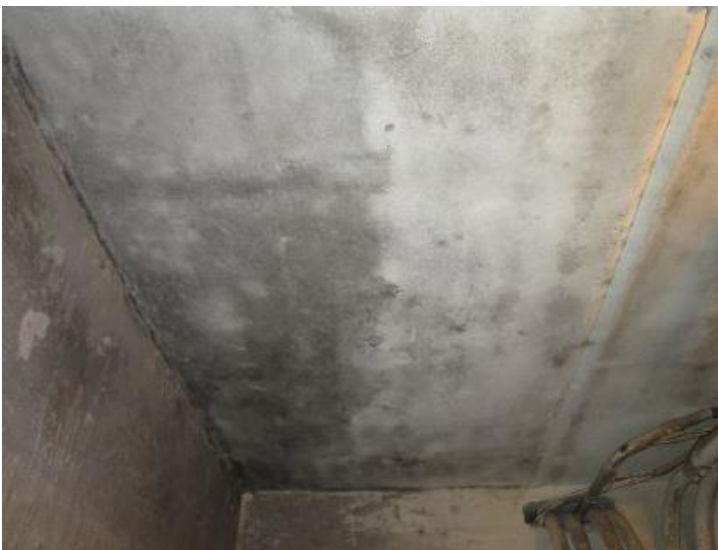
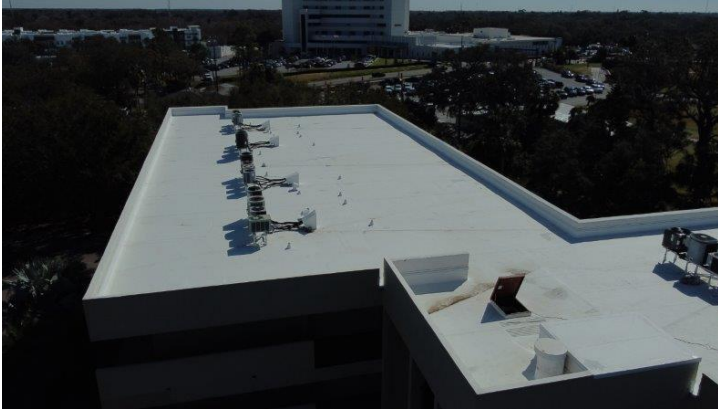
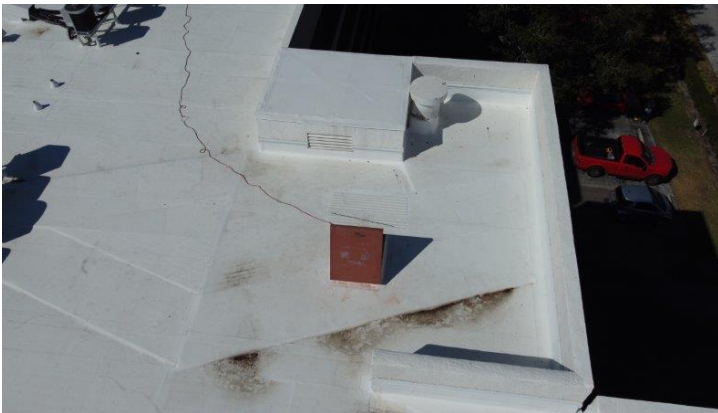
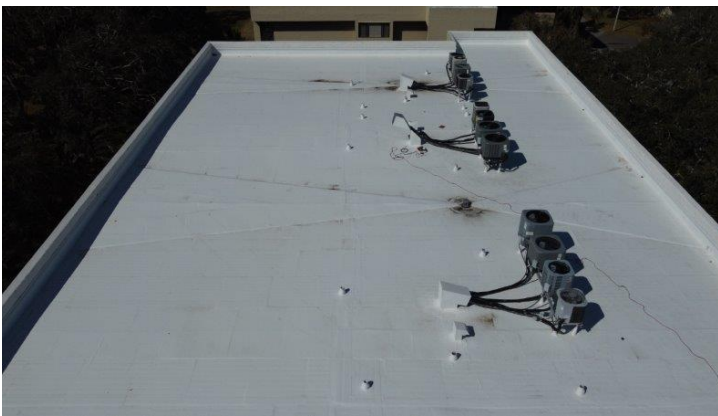
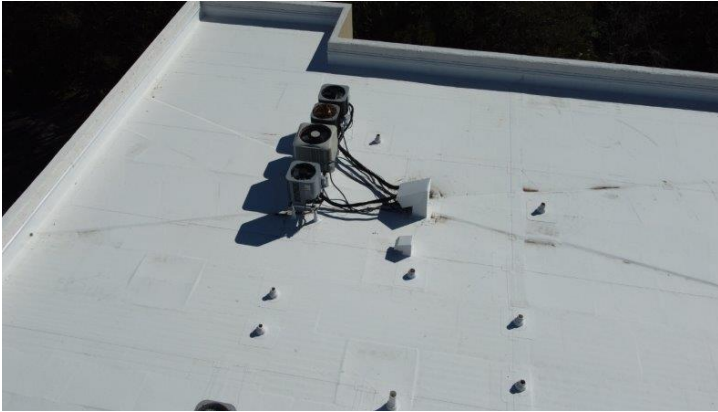
Roof Construction

- 1. Roof Covering:** **FBC Equivalent**
Comments: The roof covering was replaced in 2024. The roof permit was confirmed and the permit number is 24-572. This roof was verified as meeting the building code requirements outlined on the mitigation affidavit.
- 2. Roof Deck Attachment:** **Reinforced Concrete Roof Deck**
Comments: Inspection verified a roof structure composed of pre-cast structural concrete designed to be self supporting and integrally attached to the wall / support system.
- 3. SWR:** **No**
Comments: SWR does not apply to reinforced concrete roof decks.
- 4. Opening Protection:** **None or Some Glazed Openings**
Comments: No opening protection verified at time of inspection.
